FIG. 1. MUTUAL LIFE INSURANCE CO. BUILDING, SANSOME AND CALIFORNIA STS., SAN FRANCISCO, CAL.

THE CONDITION OF THE STEEL WORK IN A SAN FRANCISCO BUILDING ERECTED 13 YEARS AGO.

By FRANK B. GILBRETH,* M. Am. Soc. M. E.

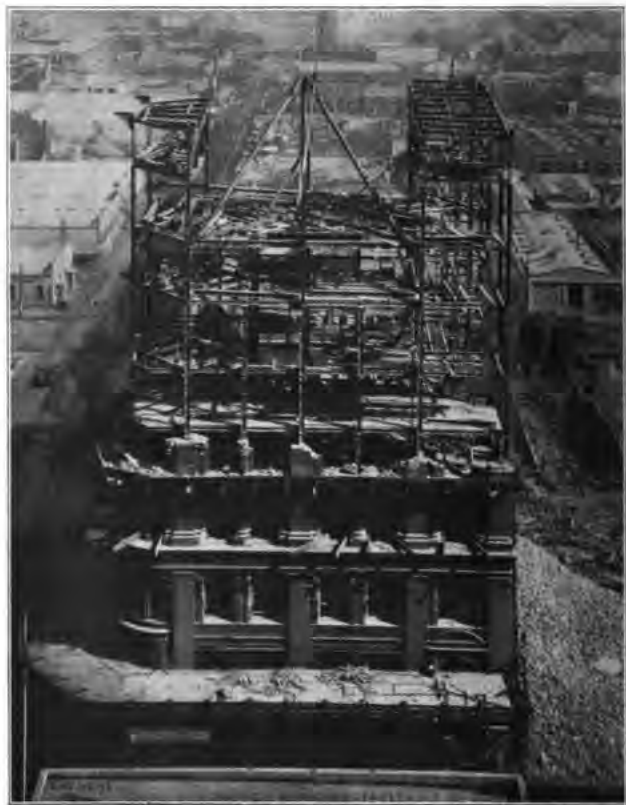
Sansome St. Front viewed from Merchants' Exchange on Oct. 28, 1906, during removal of six upper stories for rebuilding. The walls, partitions and most of the floor arches have already been taken down. The wreckage of the intermediate roof-truss over the deep central part of the eighth story has also been removed. A stiff-leg derrick is being set up on the eighth floor, using an old wooden flagstaff as gin-pole.

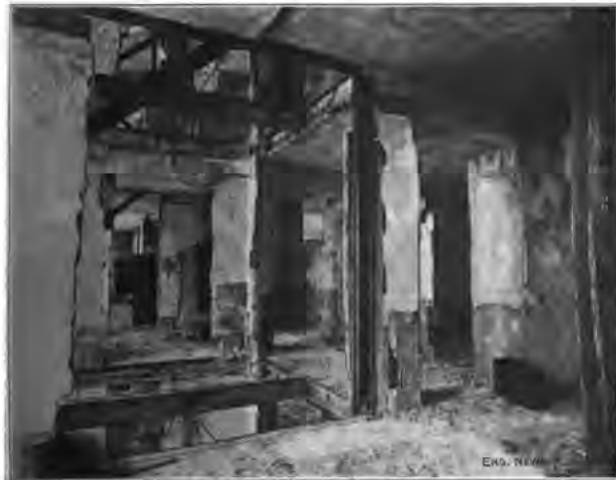
FIG. 2. APPEARANCE OF INTERIOR AFTER REMOVAL OF LOOSE RUBBISH.

View at Elevator Shaft, Fifth Floor

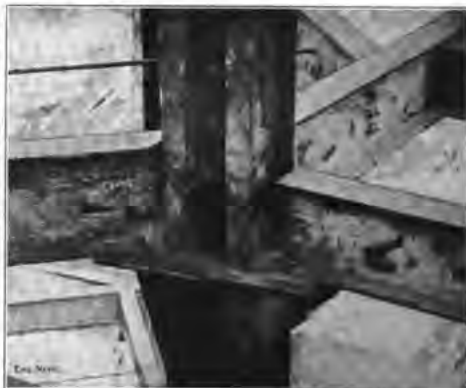
FIG. 3. A COLUMN SPLICE AND THREE FLOOR BEAM CONNECTIONS, SHOWING PRACTICALLY NO RUSTING (CINDER CONCRETE).

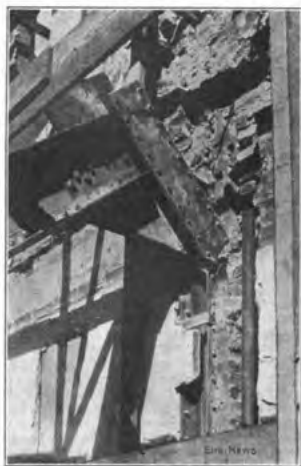
Fig. 4. A Wall-Column Broken Off by Fall of Roof Truss Over Central Part of Eighth Story; Attachment of Lower Chord of Truss. No material rusting appears on either column or truss.

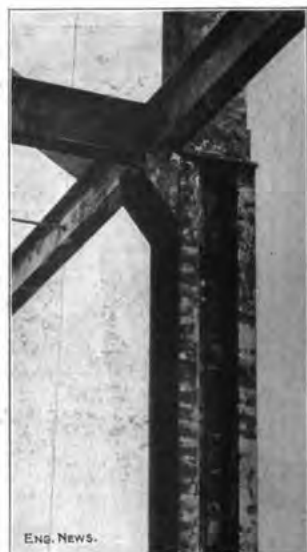
Fig. 7. Appearance of a Wall-Column after Removing Masonry.

Floorbeam connections at fifth floor level. The column, floorbeams and details show an excellently preserved surface.

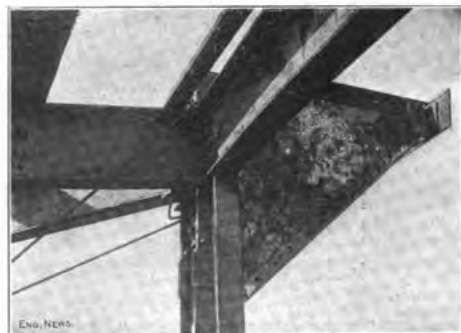
FIG. 5. CORNICE BRACKET AT ROOF LEVEL. The web-plate and flange-rivets are badly rusted.

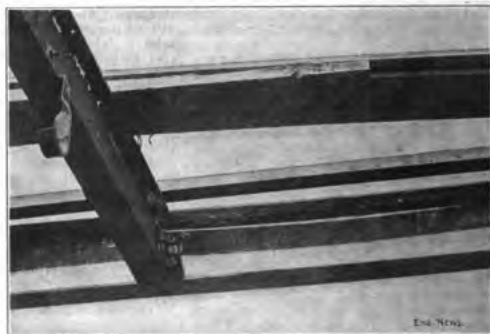
FIG. 6. EXCELLENT PRESERVATION OF BEAM WHICH WAS PARTIALLY BURIED IN CINDER CONCRETE.
